**An Assessment of the Impact of Social Trails Use
on Cultural Resources in Technical Area 70,
Los Alamos National Laboratory, New Mexico**

**Jennifer E. Nisengard and Sherri Sherwood,
Environmental Protection Division,
Risk Reduction Office and Ecology and Air Quality Group**

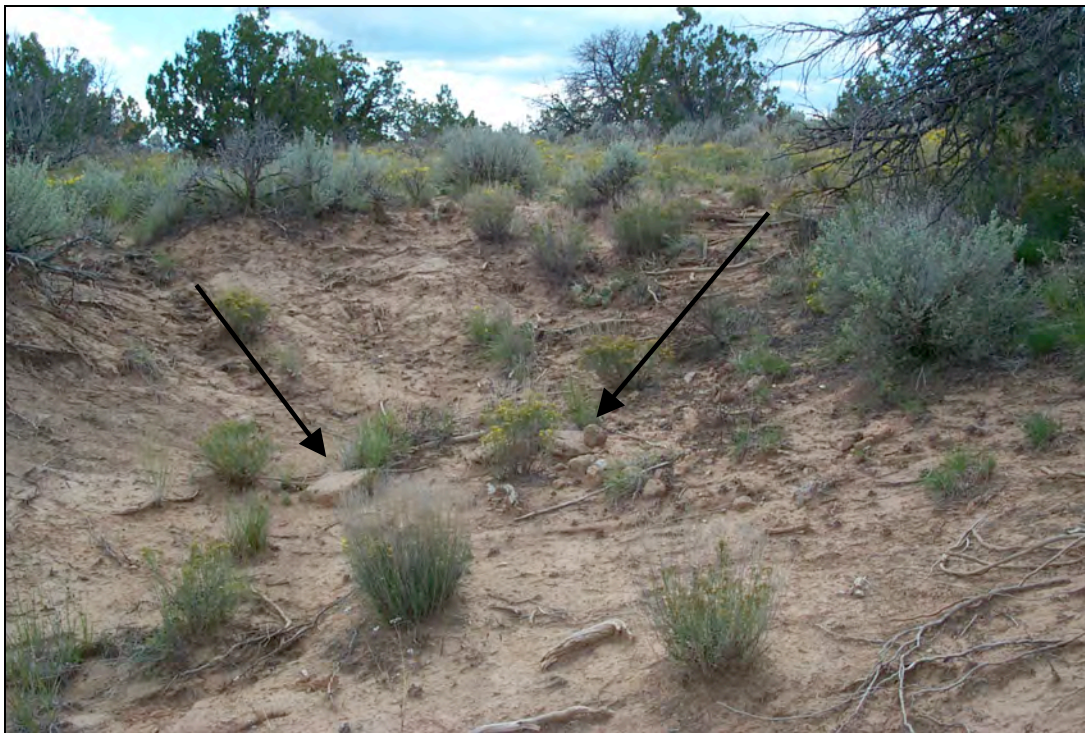
The three primary impacts related to cultural resources in TA-70, caused or exacerbated by recreational trails use, are erosion (Figure 3), looting (Figure 4), and vandalism and/or modern disturbances, some of which are recent and some of which are historic (Figure 5). Natural erosion, primarily from wind and water, accounts for the majority of site and trail impacts. Areas of TA-70 have been impacted by severe erosion, with tree roots visible at many sites along the trail routes; the location of this TA, atop a mesa, accounts for some of the erosion in the area. An additional cause of the severe erosion in the TA is that grazing and wildfire prevention efforts have allowed piñon and juniper to establish in areas that were previously grasslands. These trees are able to out compete the understory for water and nutrients so the grasses die off, leaving the soils unprotected and subject to increased erosion (Sam Loftin, personal communication).

Figure 3. Severe erosion impacts a Coalition period Ancestral Pueblo site (arrows indicate the shaped tuff blocks used to construct the roomblock).

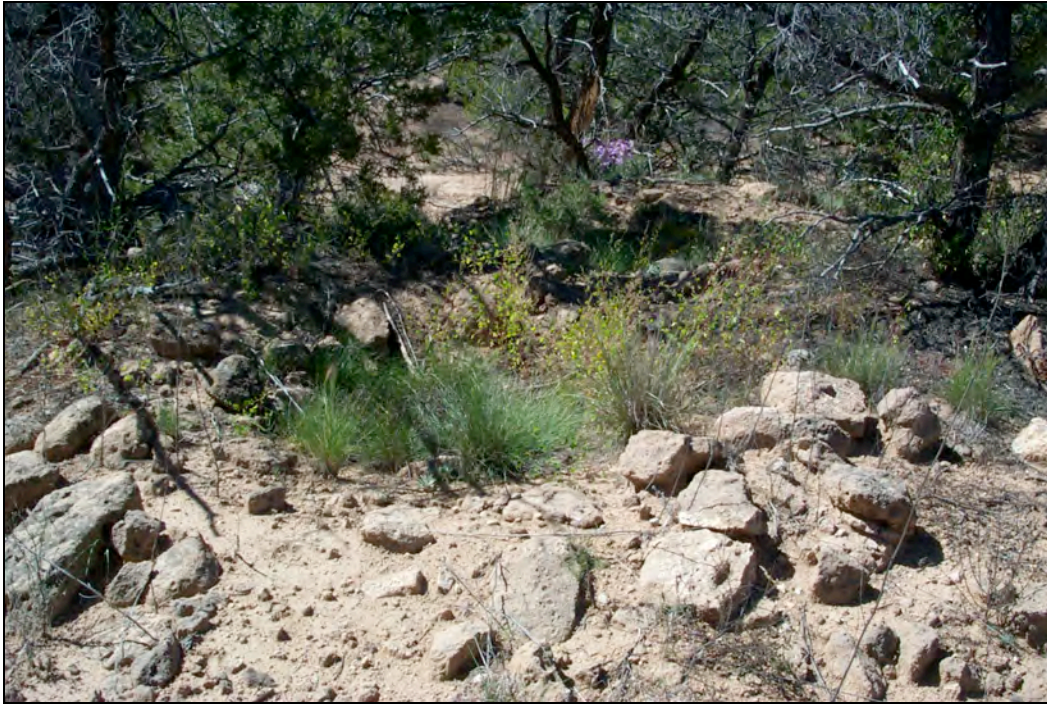
Figure 4. A depression in the center and piles of the shaped blocks provide evidence for site looting at this Ancestral Pueblo site.

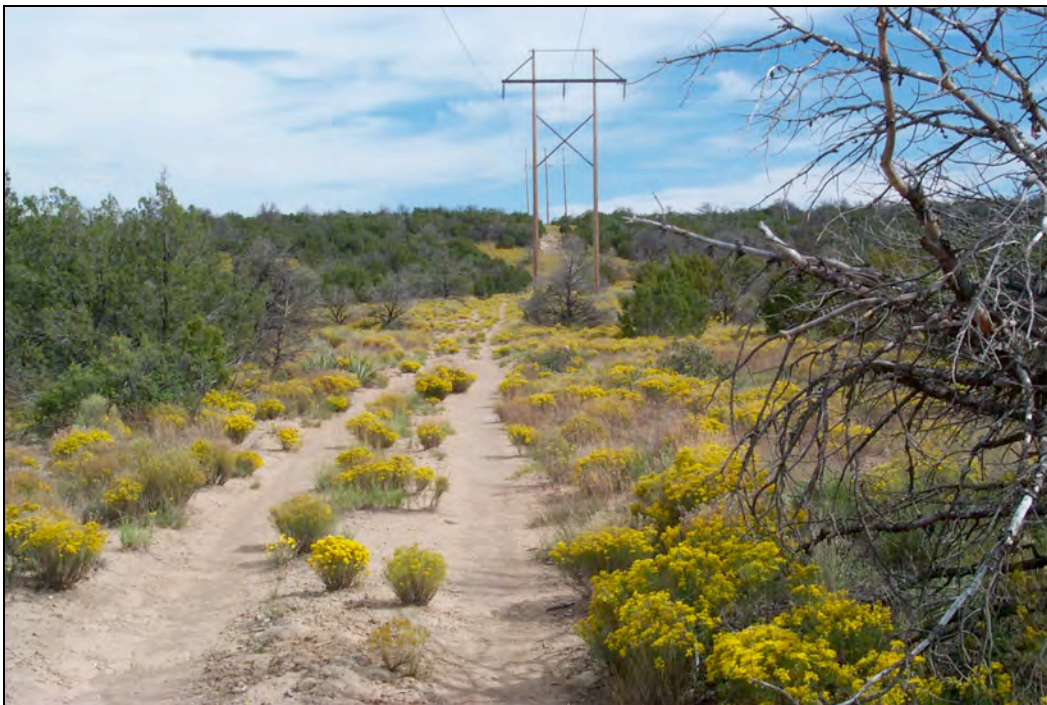
Figure 5. Erosion occurring along a power line road.

In some cases, recreational and LANL mission activities, including the construction and use of two-track roads, fire roads, and new trail segments, intensify the impacts of natural erosion. Figure 5 illustrates increased damage from erosion to a trail segment and an artifact scatter

resulting from construction of a power line in TA-70. The effects of erosion on trail segments and cultural resources can be mitigated to some degree with better land management methods (e.g., tree and grass planting as well as other erosion controls included in LANL projects). Recreational trails users and LANL mission activities sometimes impact archaeological resources unintentionally; however, results of these activities are detrimental to these resources.

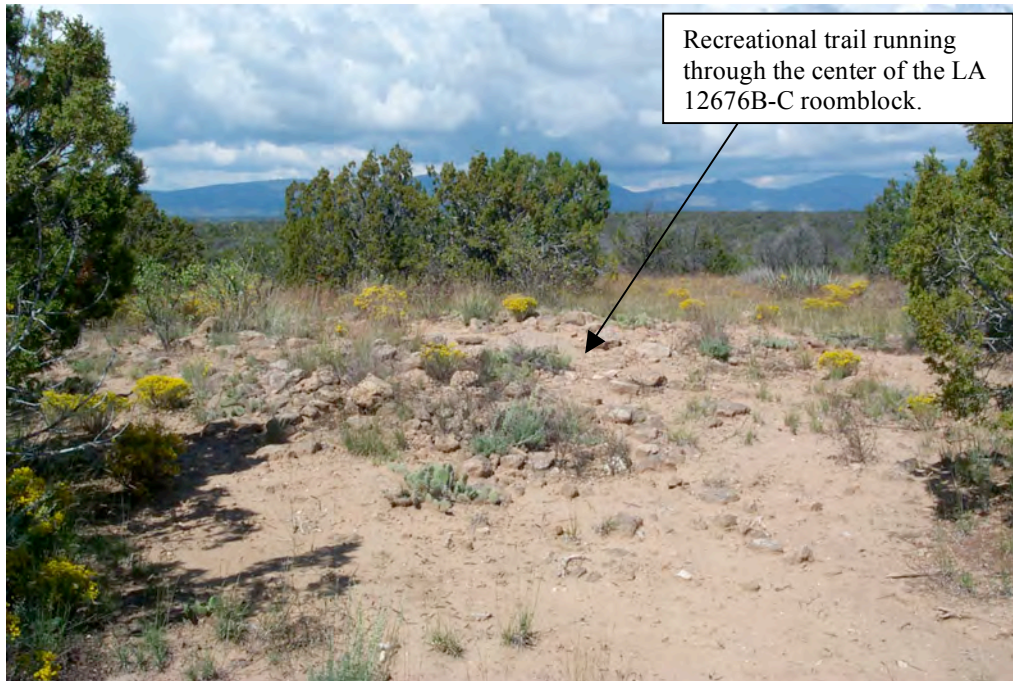
LA 12676B-C is a Coalition period roomblock impacted by erosion and the use of a road and Trail Segment 2B. Erosion at the site is minor when compared with other sites in TA-70. The road and trail have created the primary site impacts. However, many artifacts, including ceramics, chipped stone, and ground stone, were visible in the road bed, so casual collection activities do not appear to be impacting the site's integrity (Figure 6). The two-track road runs through the eastern midden area associated with the site (Figure 7). During the site visit, assessors recommended diverting the road away from the midden to minimize future impacts to the site. Because the area is relatively flat with few trees, the road running through the site should be blocked and could be rerouted with minimal effort.

Figure 6. LA 12676B-C is a Coalition period pueblo roomblock; Trail Segment 2B runs through the center of the site (see inset).

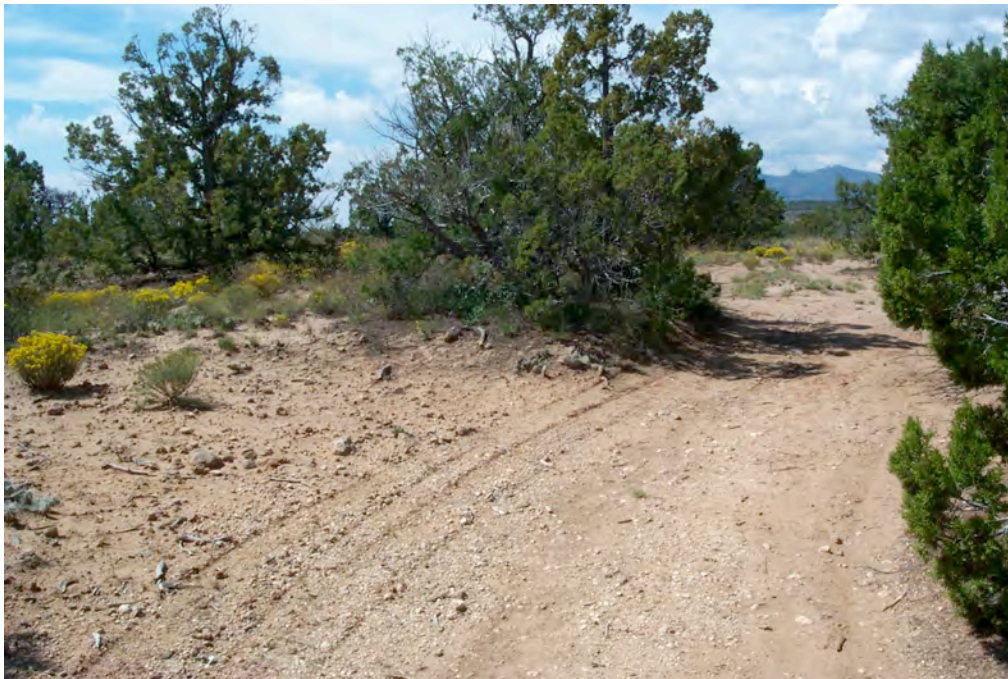
Figure 7. The eastern midden at LA 12676B-C is bisected by the two-track road.

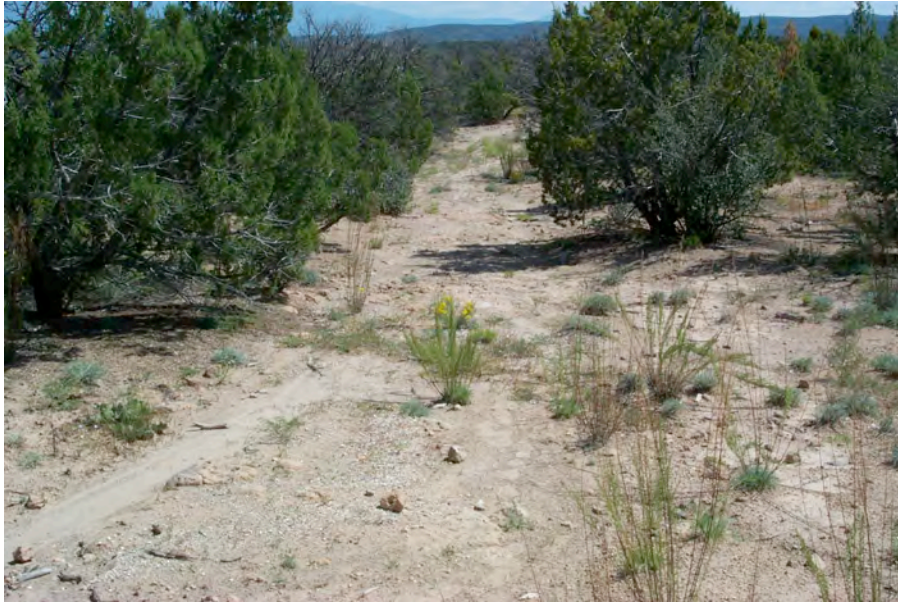
LA 139567 is a Late Archaic lithic scatter bisected by an infrequently used two-track road (Figure 8). The road has formed a channel that runs through the site and there is some modern trash at the site. Assessors recommend closing this portion of the road to prevent future impacts to the site as it does not appear that the road is heavily used.

Figure 8. LA 139567, two-track road bisects the Late Archaic site.

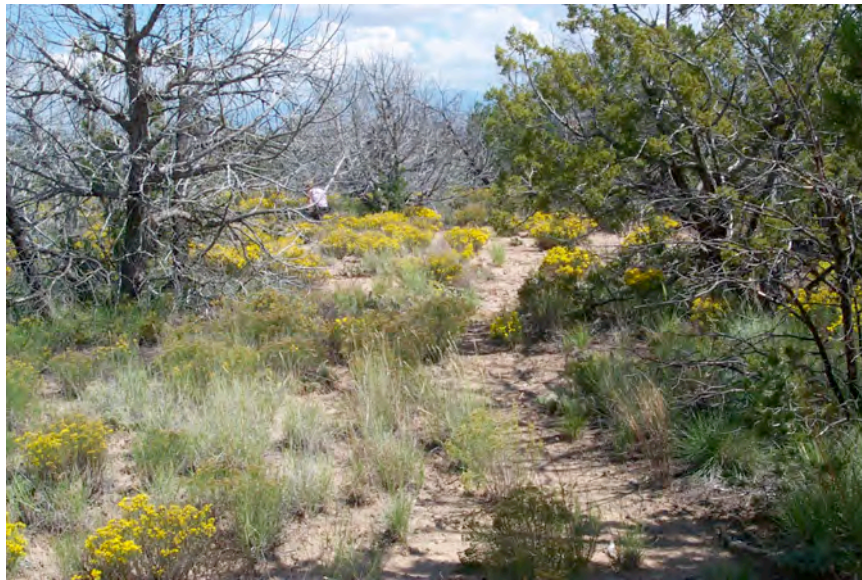
LA 21647 is an Ancestral Pueblo period roomblock impacted by Trail Segment 2B. The trail/road leads up to the site and a trail runs along the southwest side of the site while use of the

Figure 10. Trail Segment 2B and LA 21647. Trail leads up to site and runs along the southwestern side of the site.

road is impacting the associated midden (Figure 10). Assessors recommend closing the road before it reaches the site to prevent future impacts to the roomblock and the midden.

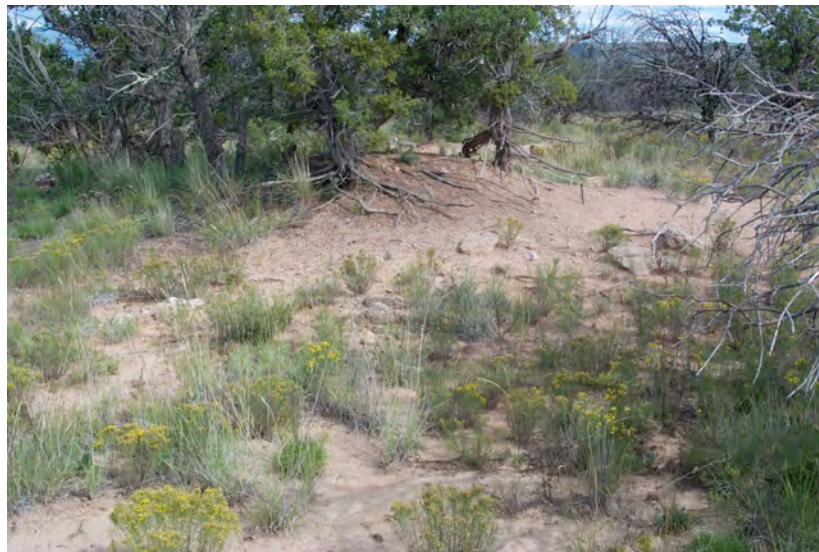
SWEIS 130 is very similar to SWEIS 129, it is a one- to three-room structure situated along Trail Segment 2C that has been, and continues to be, impacted by severe erosion. Erosion controls would likely benefit the site—if any of the trees that have exposed roots fall over they will further damage the site (Figure 13). Assessors also suggest removing the string from the site.

Figure 13. Trail Segment 2C and SWEIS 130, a one- to three-room room structure, impacted by severe erosion.

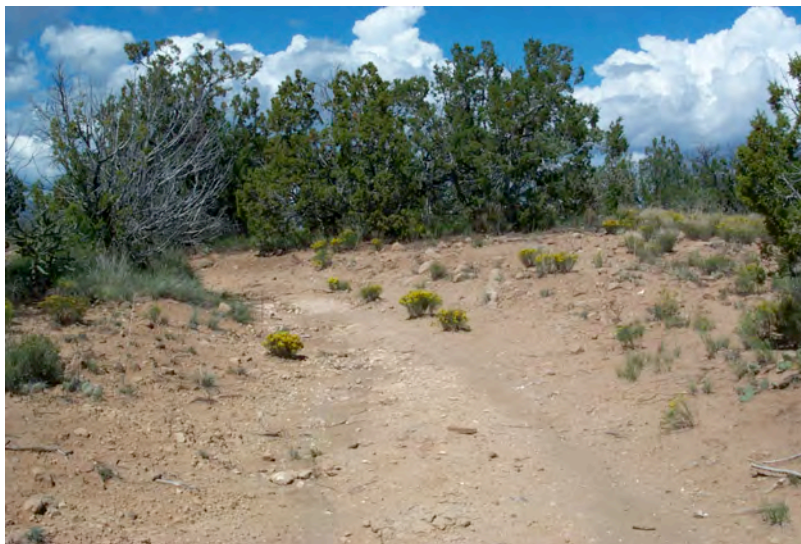
LA 29794 is a Coalition period roomblock situated in an easily accessible area of TA-70 with a trail/two-track road that runs through the site (Figure 15). The site is littered with broken glass and cans and continues to be impacted by the trail/road. Assessors recommend that the trail/road be rerouted with the old road fenced off and some reseeding and other erosion control measures undertaken to protect the site from further damage.

Figure 15. Trail Segment 3B and LA 29794, a Coalition period roomblock, impacted by recreational trails use and littering.

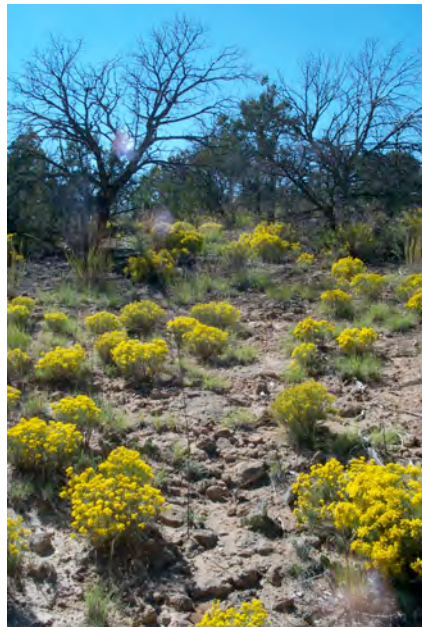
LA 139553 is a Classic period lithic and ceramic scatter that has been subject to severe erosion (Figure 17). Trail Segment 4A does not appear to be impacting the site, but assessors have recommended erosion controls at the site.

Figure 17. Trail Segment 4A and LA 139553, a Classic period lithic and ceramic scatter, impacted by severe erosion.

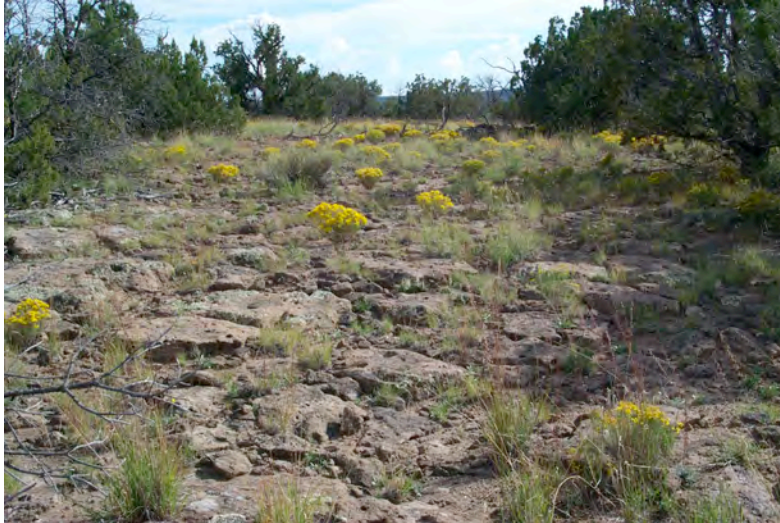
LA 29788 was identified as a Coalition period lithic and ceramic scatter situated on bedrock within the vicinity of Trail Segment 4B (Figure 18). The lack of deposits within the site area caused assessors to question the accuracy of the site characterization. It is possible that all of the artifacts initially associated with the site have been collected; however, assessors recommend an additional site visit to determine whether or not the site is eligible.

Figure 18. Trail Segment 4B and LA 29788, a Coalition period lithic and ceramic scatter, impacted by erosion and possible collection activities.

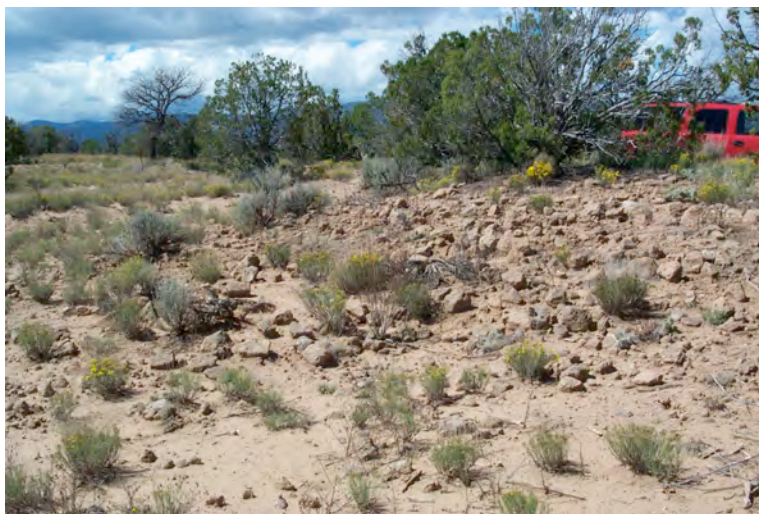
LA 29789 is a Coalition period pueblo roomblock and is impacted by the two-track road/trail that bisects the site (Figure 19). There are artifacts scattered throughout the surface of the site. There is some evidence of looting at the site, although not to the same degree that is evidenced at other sites situated within TA-70. Broken glass was also identified during the site visit. Assessors recommend data collection and rerouting the road/trail away from the site, as it appears to promote erosion, artifact collection, and littering.

Figure 19. Trail Segment 3 and LA 29789, a Coalition period roomblock, impacted by trails use, a road that runs through the site, possible looting, and littering.

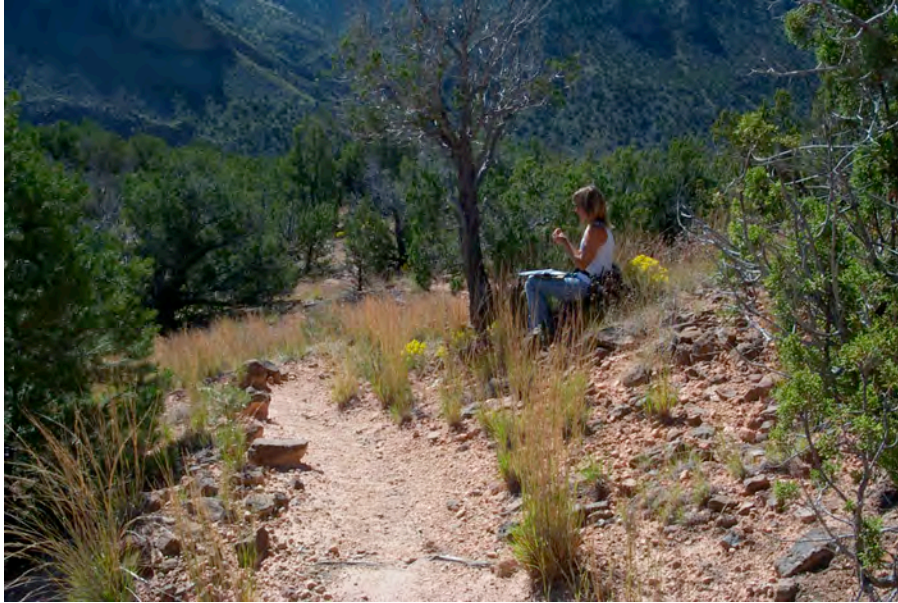
LA 29791 was identified as an undetermined Ancestral Pueblo lithic scatter. Trail Segment 4B runs through the site (Figure 20). No artifacts were encountered during this site visit and assessors recommend that this site be removed from the cultural resources database and/or listed as ineligible.

Figure 20. Trail Segment 4B and LA 29791, an undetermined lithic scatter.

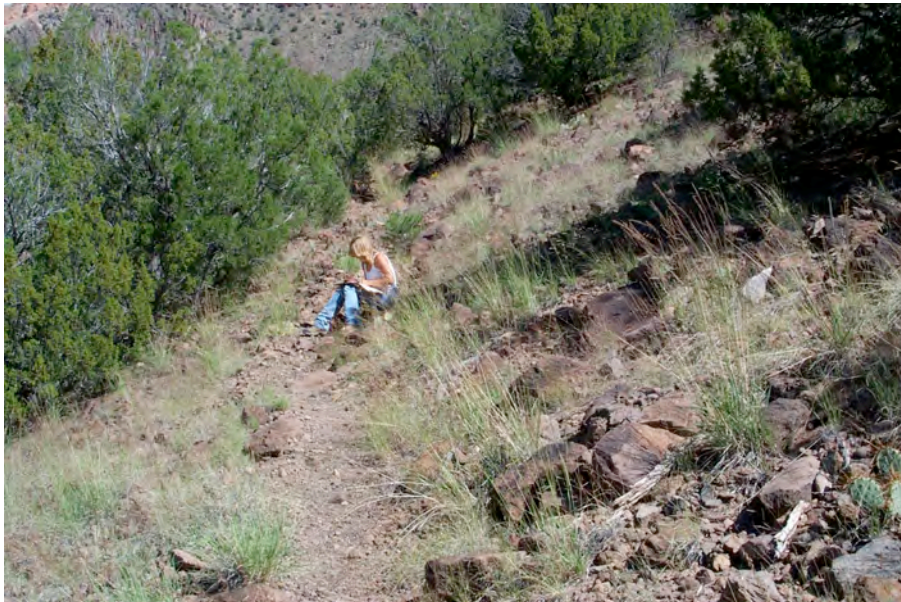
LA 29792 was identified as an undetermined Ancestral Pueblo lithic and ceramic scatter. Trail Segment 4B runs through the center of the site (Figure 21). Assessors found that the sixty percent slope of the location and one hundred percent collection of the site's artifacts by the PARP make the site questionable and suggest removal from the database.

Figure 21. S. Sherwood sits on Trail Segment 4B in the center of LA 29792.

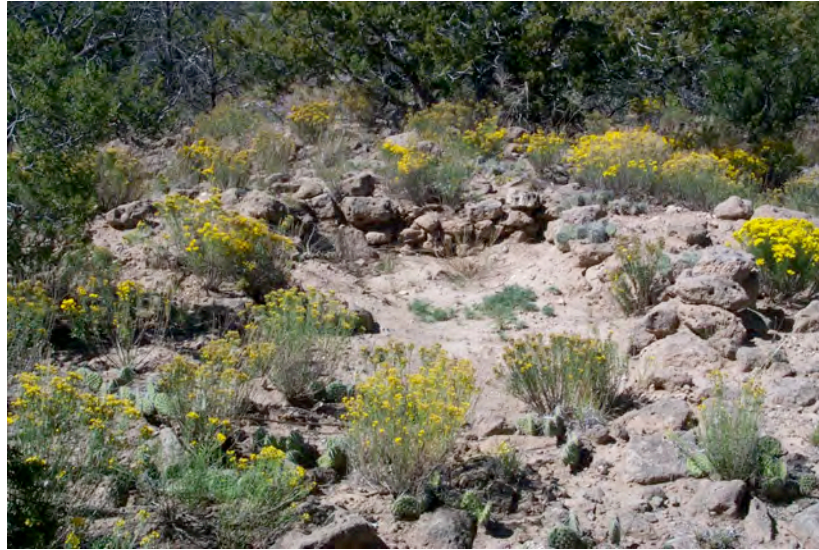
LA 139486 is an Ancestral Pueblo roomblock that has been subject to extensive looting within the last couple of years (Figure 22). A tree has recently fallen into the center of the rubble mound. There are artifacts present on the surface of the site, but recent looter's pits and evidence of other collection activities suggest that the site has been impacted because of its accessibility and characteristics. Assessors recommend string removal and rerouting of the trail away from the site and some revegetation of the area to increase site protection.

Figure 22. Trail Segment 5C and Ancestral Pueblo roomblock LA 139486. The site has been subject to extensive looting. Recreational trails use has impacted this site.

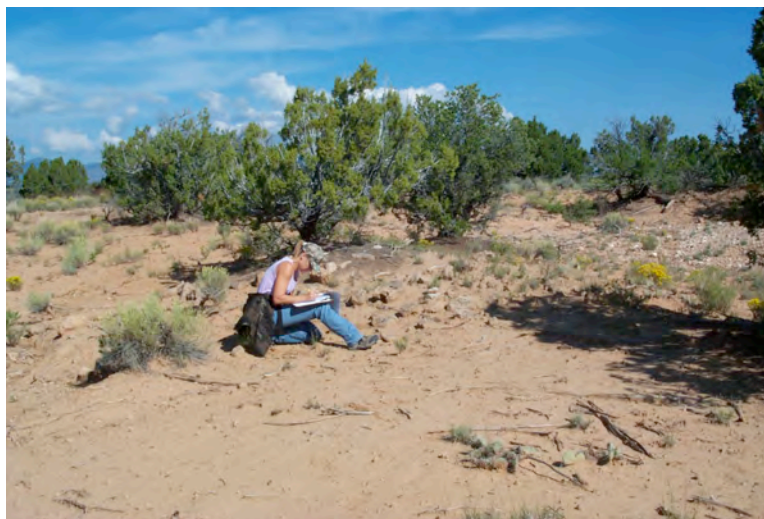
LA 139500 is a one- to three-room structure that has been impacted by severe erosion more than any other activity (Figure 23). The site is adjacent to LA 12677, another one- to three-room structure. The trail leading to the site is not well used and is not visible any longer as a result of the erosion. Assessors recommended removal of the remaining string at the site.

Figure 23. Power Line Segment 1 SW and a one- to three-room structure (LA 139500) impacted by severe erosion.
